# Polyrock Ranch Fish Passage & Riparian Enhancement on Jordan and Coyote creeks

## Project Background

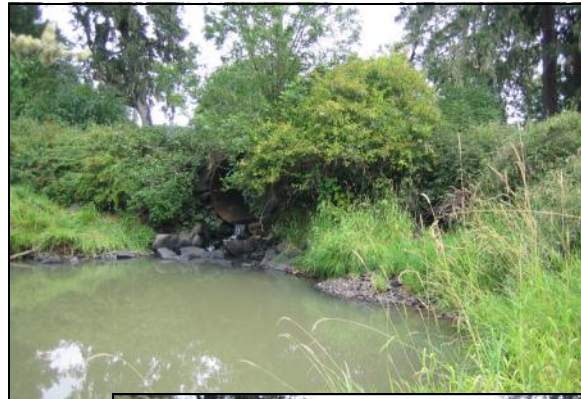
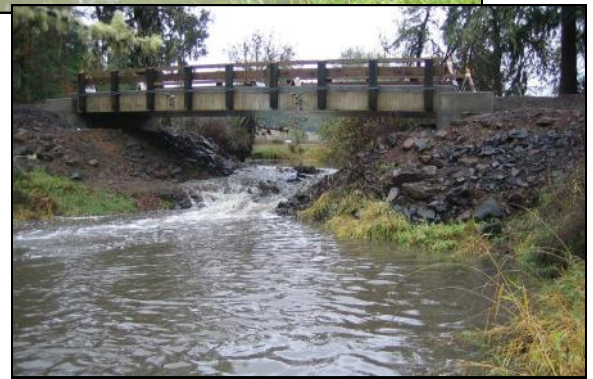
**Before & After:** The top photo shows the two foot drop at the culvert's outlet in the summer. Now the crossing is passable to fish year round .

The culvert on Coyote Creek was replaced with a bridge, which was the most cost-effective solution in this case—reducing project cost by \$14,000. A total of 5 barriers were removed on Jordan Creek in 2011. Two were replaced with stream simulation pipe arch culverts which are designed to accommodate the bank-full width of the stream during winter flows. A rocked crossing replaced the northernmost culvert, and the southernmost culvert was not replaced with a crossing because access was not needed.

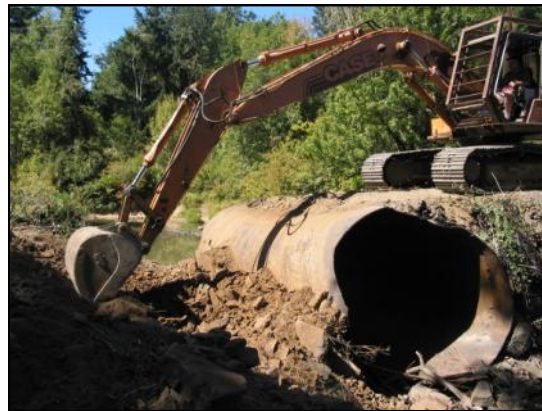
**An excavator removes the undersized culvert that blocked fish passage to 46 miles of upstream habitat.**

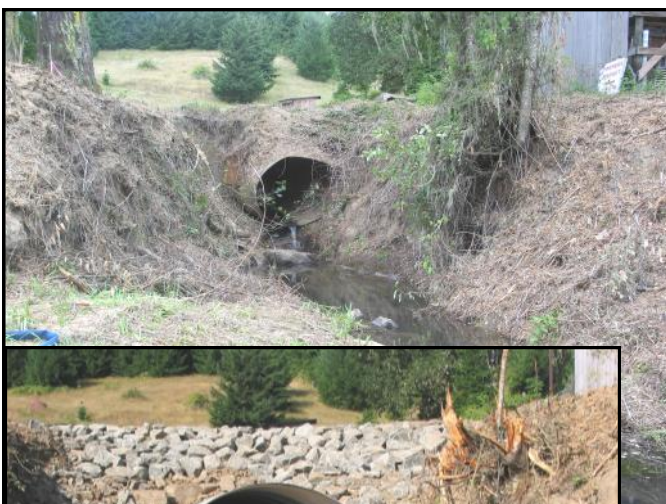
**Before & After Photos:** The top photo shows an undersized culvert perched too high above the surface of Jordan Creek to allow fish passage. It was replaced with a larger culvert that allows cutthroat trout and other native aquatic species to access cooler water and good spawning habitat.
