POLYROCK RANCH FISH PASSAGE & RIPARIAN ENHANCEMENT ON JORDAN AND COYOTE CREEKS

PROJECT BACKGROUND

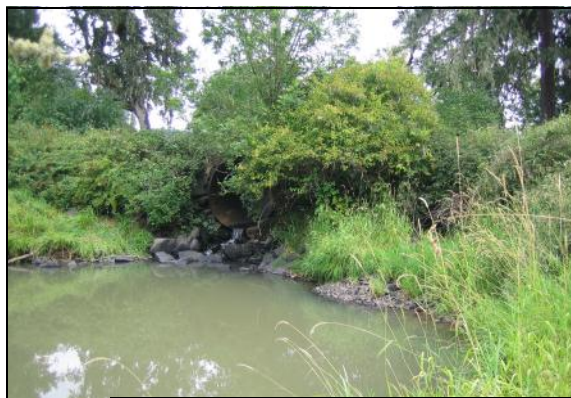
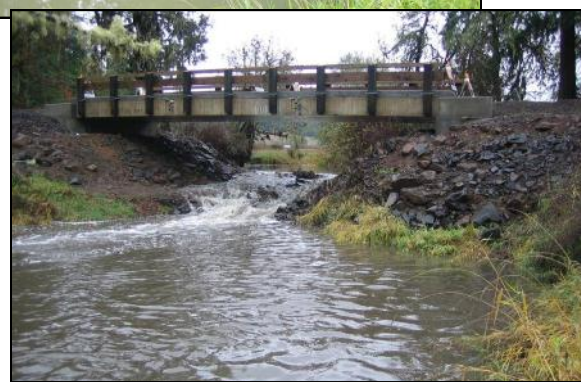
Before & After: The top photo shows the two foot drop at the culvert's outlet in the summer. Now the crossing is passable to fish year round .

The culvert on Coyote Creek was replaced with a bridge, which was the most cost-effective solution in this case—reducing project cost by \$14,000. A total of 5 barriers were removed on Jordan Creek in 2011. Two were replaced with stream simulation pipe arch culverts which are designed to accommodate the bank-full width of the stream during winter flows. A rocked crossing replaced the northernmost culvert, and the southernmost culvert was not replaced with a crossing because access was not needed.

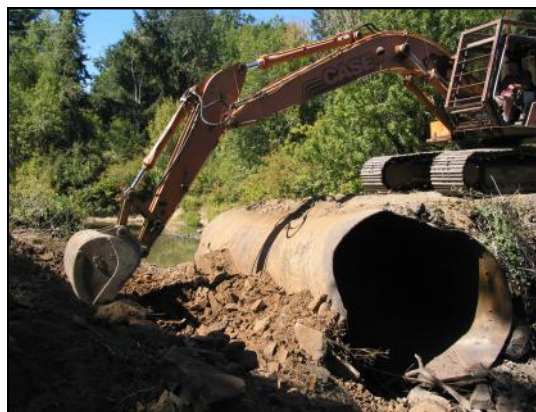
An excavator removes the undersized culvert that blocked fish passage to 46 miles of upstream habitat.
