# Coyote Creek Tributary Fish Passage & Stream Restoration at Atkinson's

## Project Background & Description

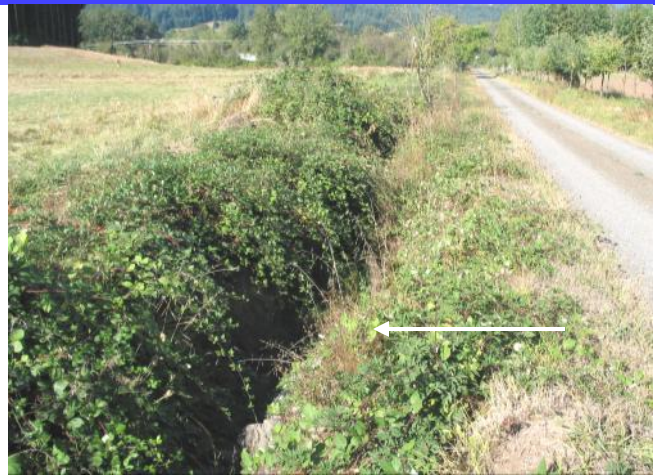
**Before the project:** The existing channel was deeply incised and lined with non-native Himalayan blackberry.

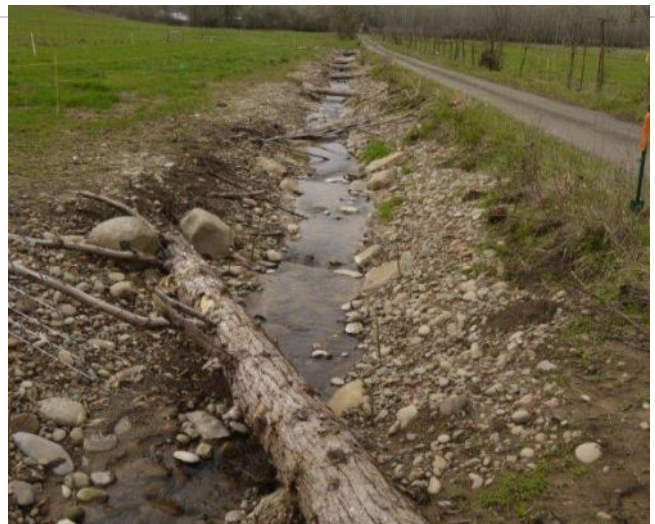
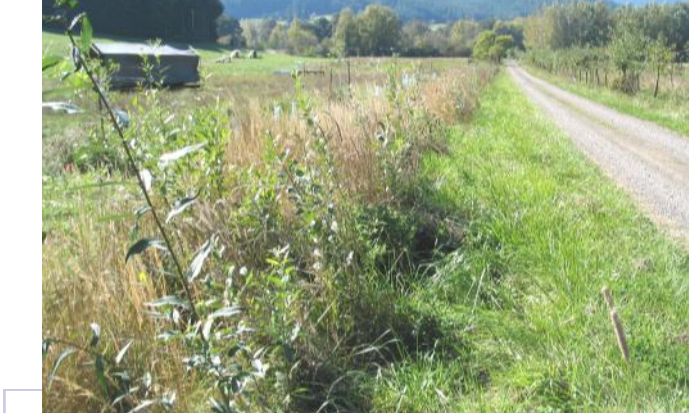
**After the project:** The blackberry were removed and replaced with native trees and shrubs. In this section, the channel was reconstructed with stream rock and log weirs. The channel cross-section is wider and shallower, which decreases erosion and improves floodplain connectivity.

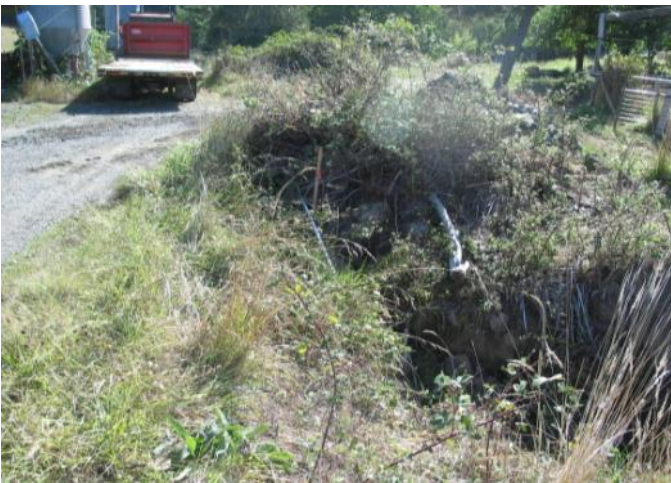
**Pre-project:** The 18" culvert was undersized and its outlet was perched above the stream.

We replaced the original 18" culvert with a 66"x 51" corrugated metal pipe arch. It was filled with two feet of river rock to provide a continual stream bed through the culvert. The first 230' of existing channel downstream of the culvert was raised by adding 95 yd<sup>3</sup> of river rock and 10 log weirs. 1,150' of new channel was excavated across the landowner's pasture and the excavated material was placed in the abandoned channel segment along the driveway. Log weirs buried at 25' intervals, erosion control fabric, and grass seeding are currently stabilizing the new channel section. Over time, newly planted native willows, trees, and shrubs will keep the channel from eroding.

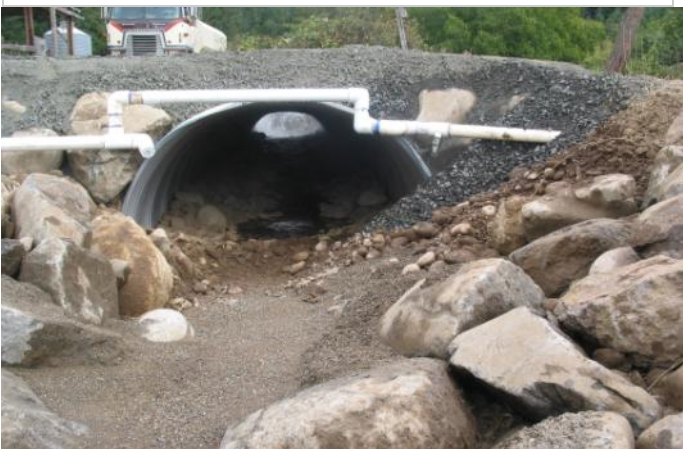
**Post-project:** The new 66" by 51" culvert was bedded with river rock to create a natural stream bottom.

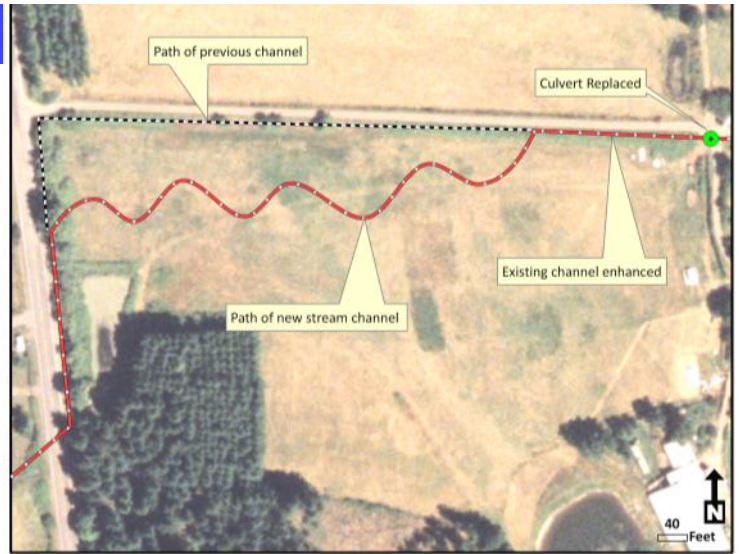
**Site Map:** The line shows the path of the tributary. The section leading away from the driveway represents the 1,150' of newly excavated channel.

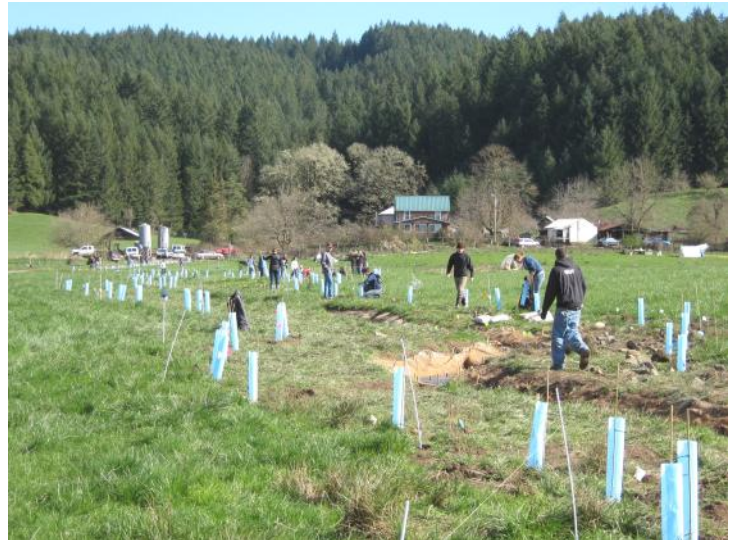
**After the Project:** Volunteers planted hundreds of native trees and shrubs along the tributary channel. The tubes help protect the seedlings and increases moisture levels.
