# COYOTE CREEK TRIBUTARY FISH PASSAGE & STREAM RESTORATION AT ATKINSON'S

## PROJECT BACKGROUND & DESCRIPTION

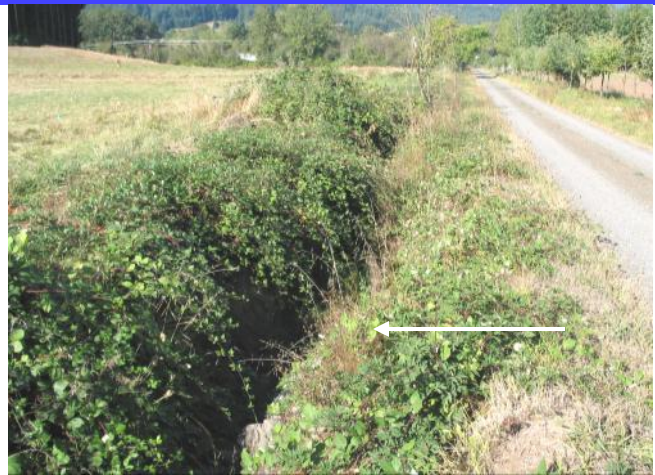
**Before the project:** The existing channel was deeply incised and lined with non-native Himalayan blackberry.

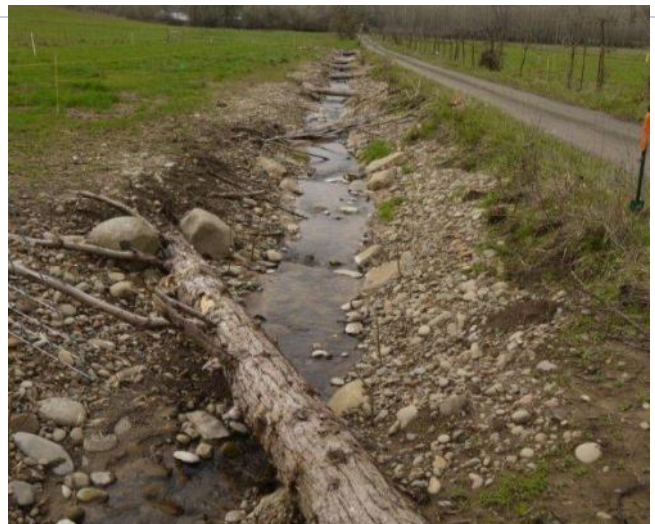
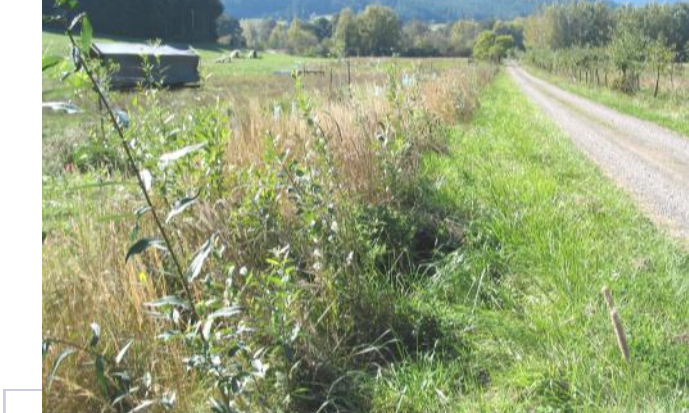
**After the project:** The blackberry were removed and replaced with native trees and shrubs. In this section, the channel was reconstructed with stream rock and log weirs. The channel cross-section is wider and shallower, which decreases erosion and improves floodplain connectivity.

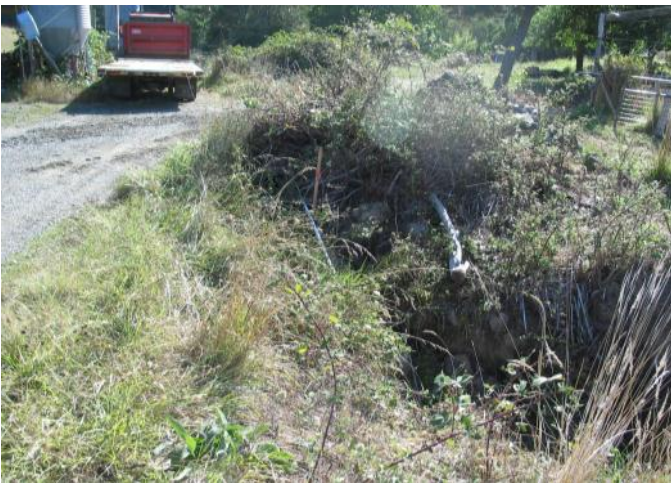
**Pre-project:** The 18" culvert was undersized and its outlet was perched above the stream.

We replaced the original 18" culvert with a 66"x 51" corrugated metal pipe arch. It was filled with two feet of river rock to provide a continual stream bed through the culvert. The first 230' of existing channel downstream of the culvert was raised by adding 95 yd<sup>3</sup> of river rock and 10 log weirs. 1,150' of new channel was excavated across the landowner's pasture and the excavated material was placed in the abandoned channel segment along the driveway. Log weirs buried at 25' intervals, erosion control fabric, and grass seeding are currently stabilizing the new channel section. Over time, newly planted native willows, trees, and shrubs will keep the channel from eroding.

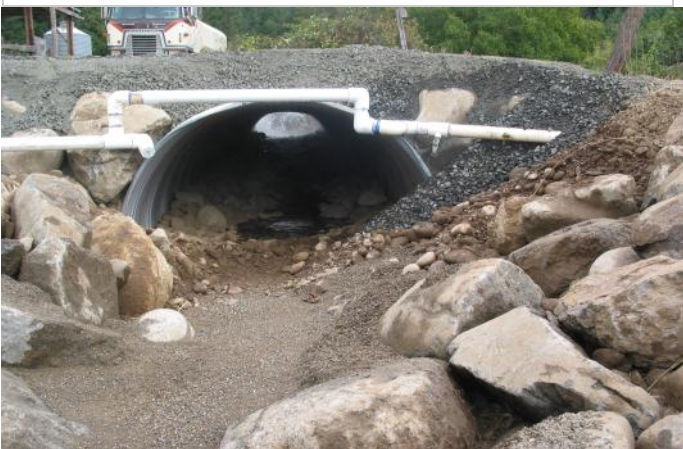
**Post-project:** The new 66" by 51" culvert was bedded with river rock to create a natural stream bottom.

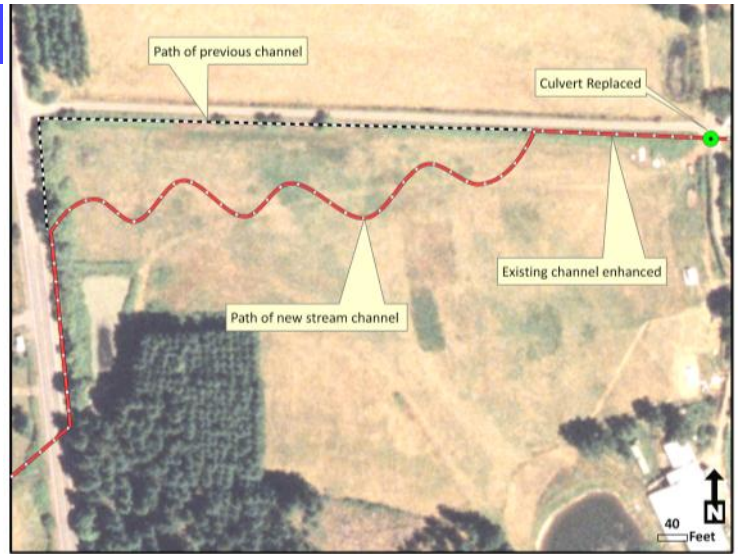
**Site Map:** The line shows the path of the tributary. The section leading away from the driveway represents the 1,150' of newly excavated channel.

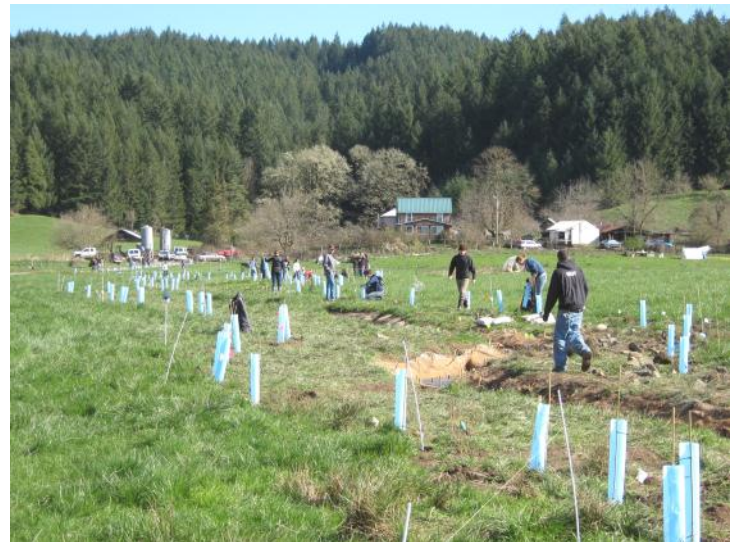
**After the Project:** Volunteers planted hundreds of native trees and shrubs along the tributary channel. The tubes help protect the seedlings and increases moisture levels.
